## **COMMERCIAL VEHICLE ENFORCEMENT UNIT (10/18-10/24)**

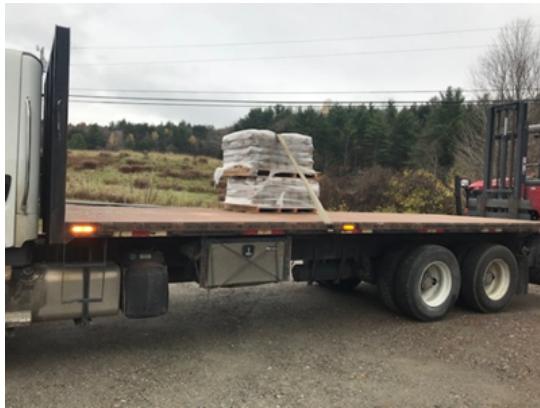
- **10/28 Cpl. Morris inspected a straight truck at the Cambridge detail because of a load securement violation. The truck was hauling pallets of stone and had only secured the freight with one strap. An inquiry revealed the load weighed 1750 pounds and two straps were required. The truck was placed out of service and driver remedied the defect.**

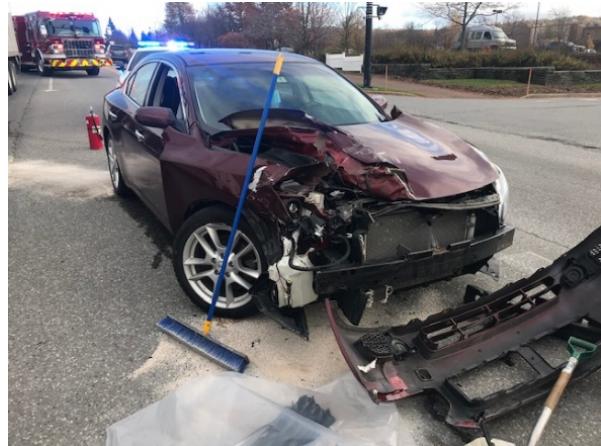
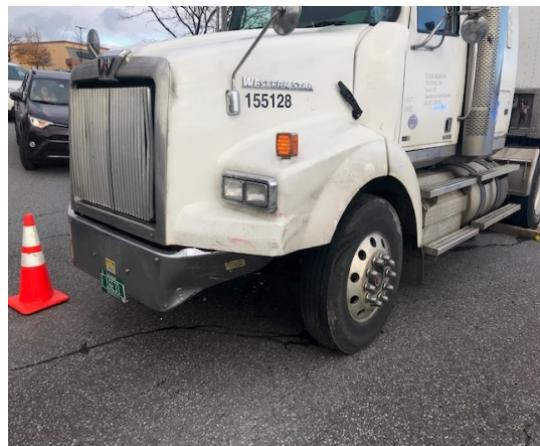
- **10/28 Inspector responded to the report of a car vs tractor trailer crash in Williston. Upon arrival, it was observed the car had sustained disabling damage and needed to be towed. No injuries were reported at the scene. There was some dispute about who ran the red light causing the collision. The**

**Inspector observed the truck tractor was equipped with a camera and requested the footage. A review of the recording clearly showed the CMV had the green light and the passenger car operator was the responsible party for the crash. A post-crash inspection was conducted.**

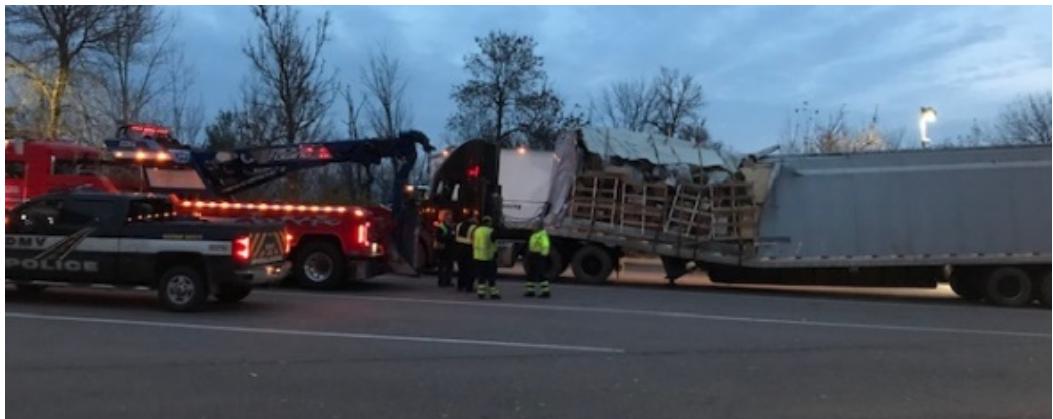
- **10/29 Inspector responded to the report of a tractor trailer that overturned on I89 in Williston. Upon arrival, he observed a recovery effort and clean up underway. According to Vermont state police and the driver, the UPS tractor trailer had crashed trying to avoid a deer and spilled a large amount of freight packages as the trailer had split open. The heavy wrecker service secured the trailer and transported it at low speed to the Williston rest area for an off load. The Inspector conducted the post-crash inspection the next day and the truck tractor was placed out of service for a significant air leak and the trailer was placed out of service for cracked, split, and sagging upper and lower frame rails and missing side posts.**

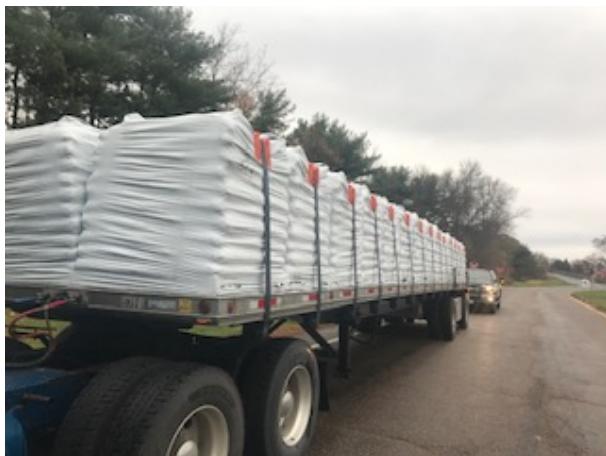
- **10/26** Inspector stopped a tractor trailer traveling south of I89 in Colchester for a load securement violation. The trailer was loaded with 1-ton pallets of bagged wood pellets and the forward pallets were only secured with one strap. An inspection was conducted, and the trailer was placed out of service. The driver remedied the defect.

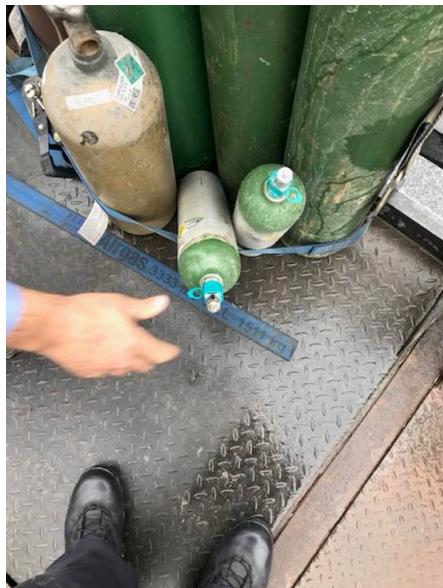
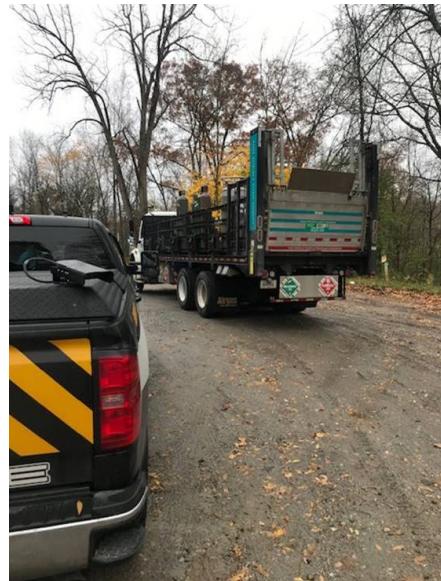
- **10/26** Inspector stopped a one-ton truck hauling an equipment trailer on I89 in the Chittenden County corridor as the trailer was not displaying a registration plate or an inspection sticker. The driver admitted the 7-ton trailer was not registered and a subsequent inspection revealed the combined GVWR was 28,000 lbs and the driver did not have a commercial driver's license. The driver was placed out of service and the trailer was grounded. A ticket was issued.
- **10/26** Inspector stopped a truck hauling hazmat cylinders for speeding on US Rte. 7 in Salisbury. An inspection was conducted, and the truck was placed out of service as one of the full cylinders was not secured on the bed of the truck.

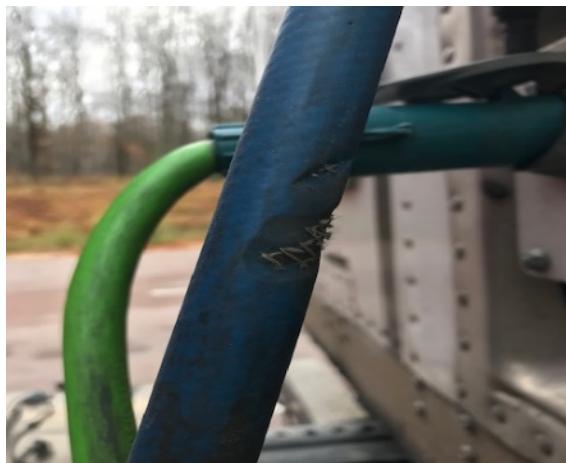
- **10/27 Inspector inspected a tractor trailer at the Williston detail. The inspection revealed a glad hand hose was chafed and the reinforcement ply was frayed constituting an out of service defect. The combination was placed out of service for repair.**

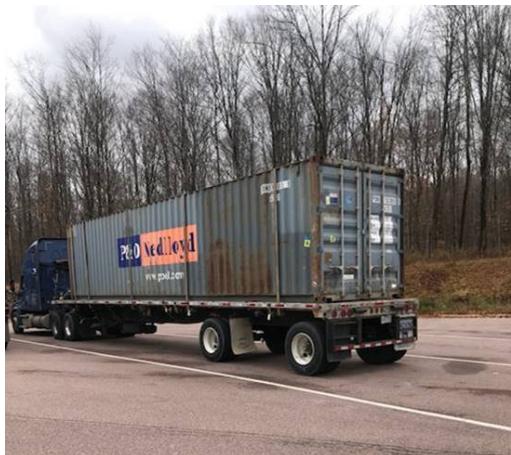
- **10/27 Inspector inspected a tractor trailer at the Williston detail. The truck tractor was placed out of service for a flat tire.**

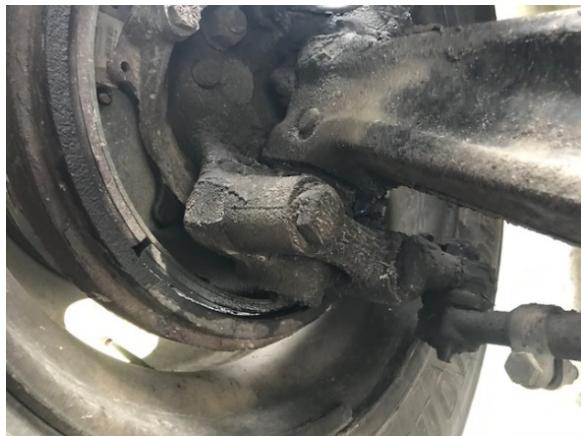
- **10/29 Inspector inspected a box truck at the Clarendon detail. The inspection revealed a wheel seal was leaking on the front axle and had contaminated the brake surface and brake friction material. The truck was placed out of service and towed for repair.**

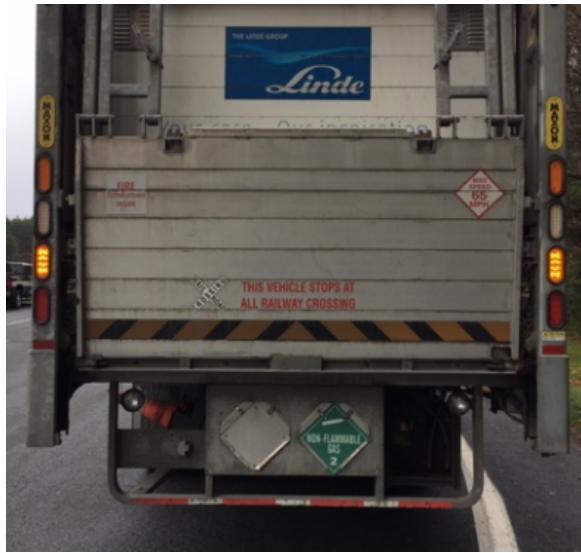
- **10/29 Inspector conducted an inspection on a truck carrying hazardous material in cylinders at the Clarendon detail. The operator, in hast, did not print off a copy of his Haz Mat shipping papers. The truck was being operated with no HM shipping papers with commodity description or quantity. The vehicle was placed out of service until a shipping paper was created.**

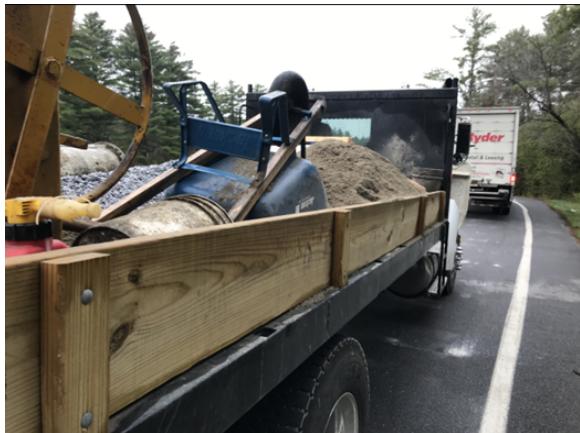
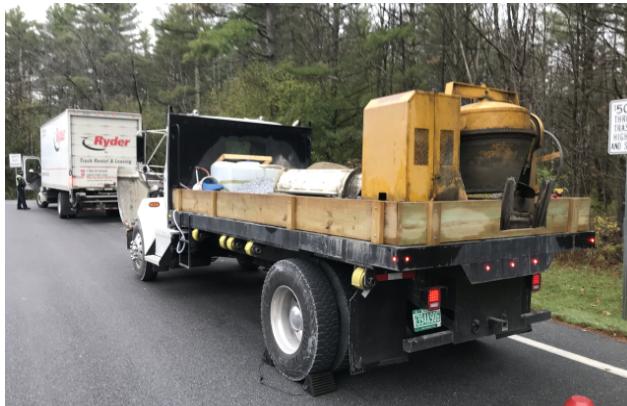
- **10/29 Inspector conducted an inspection on a straight truck at the Clarendon detail. Several items on the flatbed were unsecured, and a pile of sand was spilling over the side boards. The vehicle was placed out of service for these violations.**

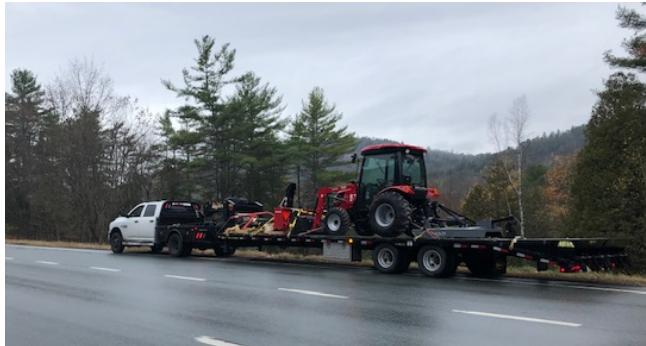
- **10/26 St Johnsbury, I-91.** An Inspector stopped an out of state CMV for not displaying the carrier name or US DOT number. An Inspection was conducted and the carrier was provided education.

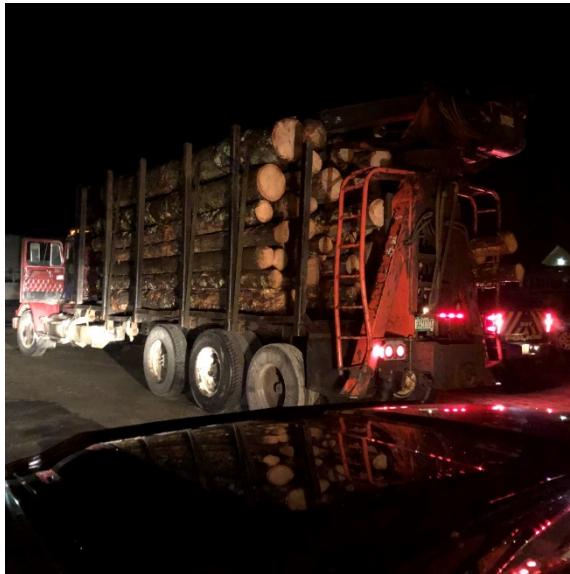
- **10/27** Two Inspectors started an early shift to get to the Hardwick area in response to a complaint about a heavy log truck that was reported to be leaving town daily at 0500. The Inspectors were able to locate the CMV, a four axle log truck, as it was leaving town. The CMV was fully loaded. The CMV was weighed and an inspection was completed. The CMV was found to be operating within its permitted tolerance for weight. The CMV was found to be in good mechanical condition and the driver was properly licensed. No action was taken against the driver or the carrier. Afterwards, the Inspectors joined the other members of the Northeast at the Lyndonville detail.

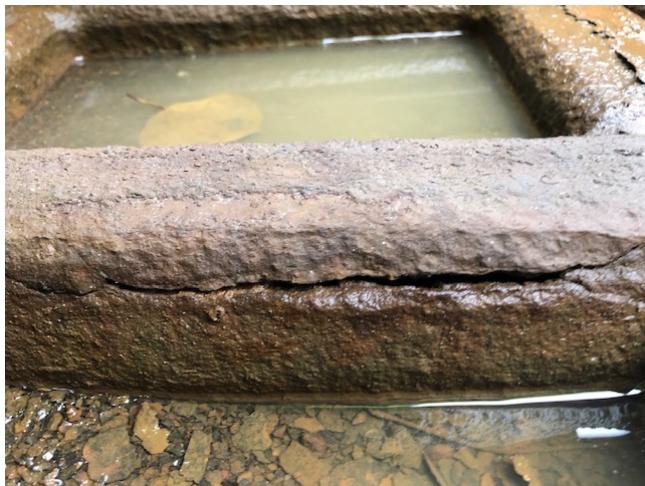
- **10/27 Lyndonville Rest Area, I-91.** An Inspector conducting a Level 1 inspection on a five axle CMV discovered this cracked fifth wheel support. The CMV was placed out of service in combination.

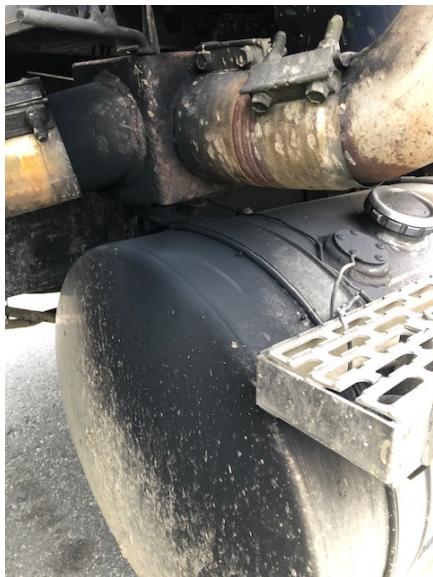
- **10/29 Coventry Rest Area, I-91.** An Inspector conducting a Level 1 inspection discovered a defective exhaust system. The exhaust system was discharging onto the fuel tank resulting in the CMV being placed out of service.

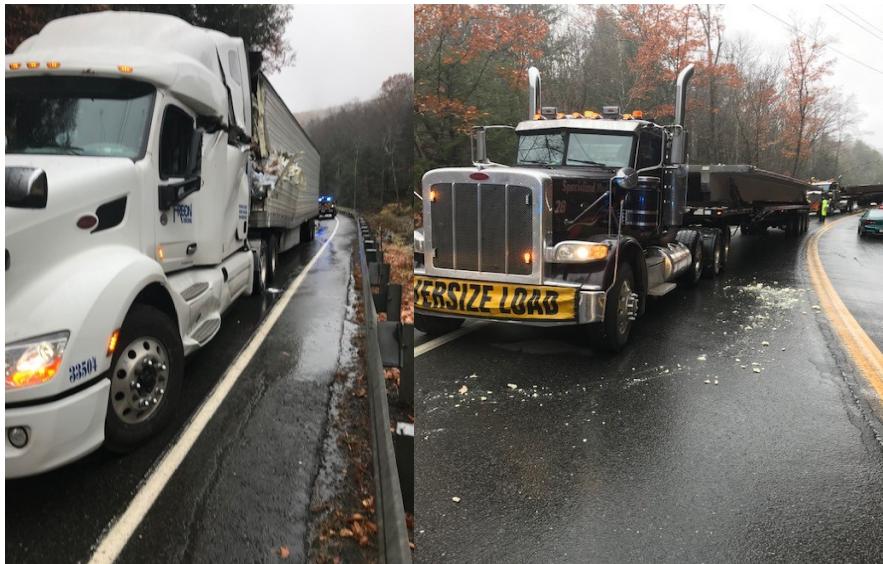
- **10/26** Inspectors responded to a CMV crash involving two tractor trailers on VT Rte 9 in the Town of Brattleboro. One 5 axle oversize load carrying a single concrete I-beam, was traveling eastbound on VT Rte 9 in Brattleboro. Another 5 axle tractor van trailer traveling westbound crossed the centerline and hit the concrete I-beam on a sharp corner next to the Maple Museum. The oversized load sustained no damage and the tractor of the van trailer sustained major damage to the driver' side door, cab and sleeper birth. The van trailer sustained major structural damage to the refer unit and driver's side rear. No injuries were reported, and the oversized load was driven away. The 5 axle truck van trailer was then towed from the scene. Both vehicles were inspected and no significant pre-existing violations were found.

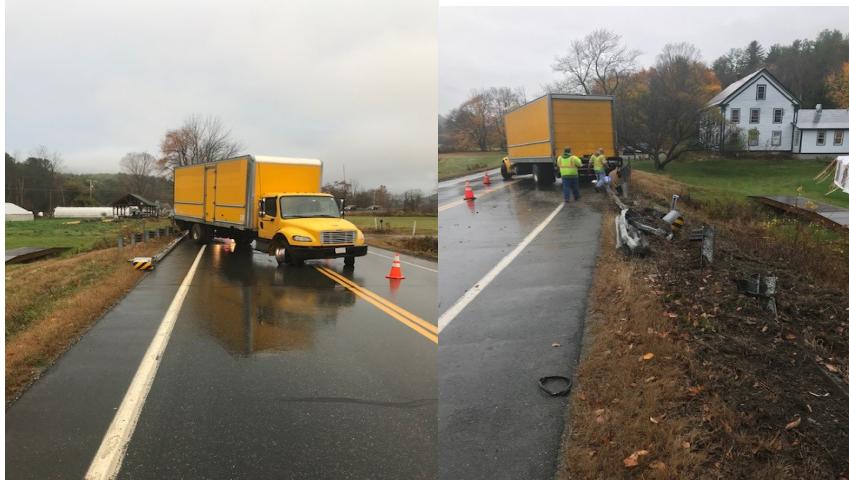
- **10/28** Inspectors were requested to conduct a post-crash inspection for single commercial vehicle crash into the guard rails with no injuries on VT Rte 30 in the Townshend. A two-axle box truck was traveling south on at an estimated 35 mph as it was dark and foggy at the time. The passenger side front tire side wall blew out causing CMV to immediately go to the right and then hit more

**than 50 feet of guard rails causing it to go off the south side shoulder. The box truck sustained damage to its passenger side front tire, rim, rear box, rear axle, and rear brake. The box truck was towed from the scene. A Level 1 post-crash inspection was completed.**

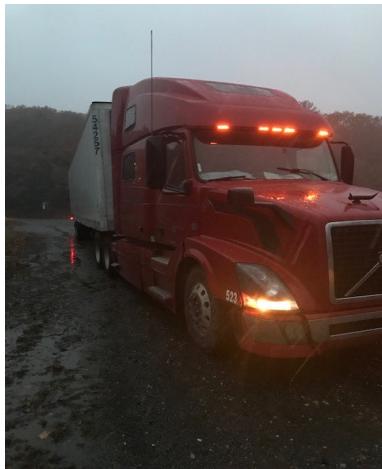
- **10/30 Inspector assisted the Vermont State Police with an incident where a tractor trailer went off I-91 in Dummerston. A Level 2 inspection was completed, and the driver was placed out of service for fatigue, 11 hour violation, and a 14 hour violation. The tractor trailer only received minor damage and was escorted to a pull off just down the road because the driver was out of service.**
